Historical Chalk Mines Below Pinner Wood School

M Hudson¹, S.J. Chandler²

This paper examines the ground investigations and surveys of historical chalk mine workings beneath a community primary school in Pinner, Middlesex and the specific use and analysis of subsurface laser scanners to identify the precise location and extent of the previously unknown and unmapped workings.

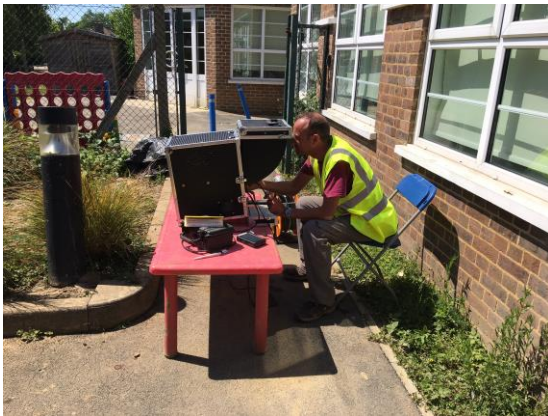
Figure 2. HD CCTV camera void surveys set up

Where voided locations were encountered, plastic casing was installed in the boreholes to the top of the voids to prevent any ground collapse so that down hole High Definition Close Circuit Television (HD CCTV) camera and laser scan surveys could be carried out.

HD CCTV camera surveys were subsequently carried out in 23 of these boreholes and C-ALS, laser surveys carried out in 34 boreholes.

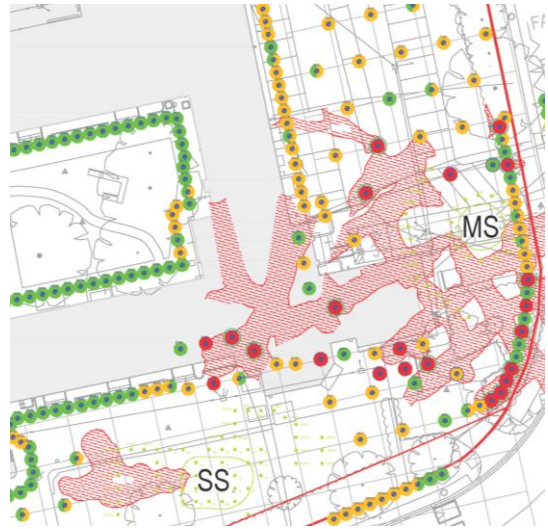
Figure 3. Interpretive plan

The borehole data was analyzed as the information was provided and a series of updated interpretive plans were produced on a regular basis as the works progressed. Refer to Figure 3 (MS is the Main Shaft and SS is the Southern Shaft). The plans presented are colour coded to show three broad classifications of ground conditions as below:

- Red – where voided or broken ground was encountered, associated with historical mining
- Yellow – where soft/disturbed ground was encountered, possibly associated with historical mining
- Green – undisturbed ground with no evidence of disturbance from historical mining

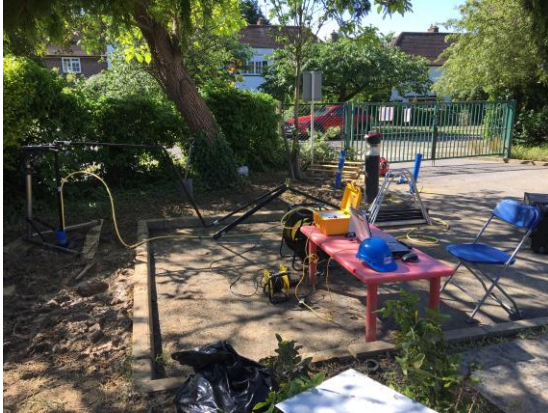
Figure 4. C-ALS survey surface installation set up

Four voids had been originally encountered within the ten boreholes around the east and south side of the school. The Cavity Auto Scanning Laser System (C-ALS) was deployed down each of the boreholes and full geo-referenced 3D laser scans were carried out on the four voids. Co-ordination of the borehole and the boretrack rods to Ordnance Survey Great Britain (OSGB) National grid and Newlyn Global Positioning System (GPS) level datum provided the baseline from which the void laser scan deployment down each borehole could be tracked until the laser scan head reached its optimum position, the approximate centre of the void, approximately 28m bgl. HD CCTV camera surveys were also carried out in each of the same voids.

A surface laser scan survey of the external school building was carried out using a FARO Focus laser scanner and a full colour 3D point cloud produced on which to provide a platform to combine with the sub-surface void laser scan surveys.

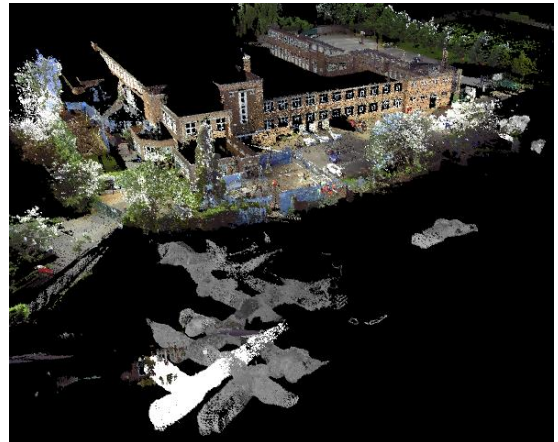
Figure 5. Navisworks point cloud model isometric

Further C-ALS surveys of each of the voids were carried out and all of the void point cloud data together with the surface point cloud data was combined into a single 3D geo-referenced model for interpretation by the Engineer. Additional HD CCTV camera surveys were also carried out in most of the same voids.

The distinct advantage of having the surface buildings and subsurface voids laser scans combined into a single geo-referenced model quickly became apparent when the location of the phase one void surveys were analysed within the interactive 3D model. Not only were the voids larger than had been anticipated, they were actually beneath the school buildings and appeared to extend even further in several directions than previously identified.

From the initial phase one scans it was clear to see that the chalk mine workings were typical bord and pillar. The C-ALS scanned a large portion of the workings and part of workings until they disappeared out of the line of sight of the scanner. The combined surface and subsurface voids was then analysed in the 3D interactive model in detail and used in subse-
